PCC of the Parish of Wiverton in the Vale

Minutes of the meeting held at 7.00 pm on Monday 12 September 2022 at St Andrew's Church, Langar

Faculty application for exterior works at Tythby Church.

This resolution requests PCC permission to apply for a faculty for exterior repairs to Tythby Church as requested by our Architect Mr Carl Andrews in his November 2019 Quinquennial Report. Details of the required works and accompanying photographs are described between **pages 9 – 16** of the report and itemised separately in the attached quote.

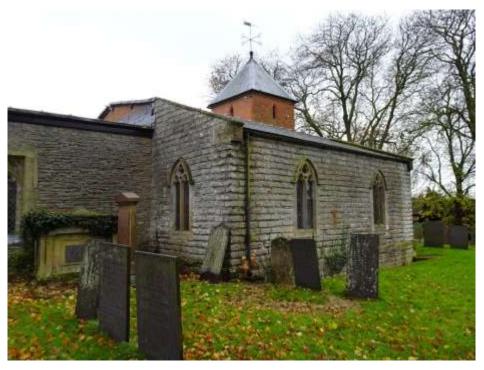
North Elevation

Church. C14 with C18 and C19 alterations. Mainly thinly-coursed rubble with quoins, with some deeply-coursed later work. Lead roofs except slate north aisle roof and tower roof. Two-bay nave with C19 north aisle, lean-to south aisle with porch, 2-bay chancel, west tower. The south aisle has a single large C18 cambered-headed window to its west, south and east sides, each with leaded glazing. 2-light chancel windows (north and south) with square heads and Perpendicular tracery and an arched doorway on the south side. 3-light C19, arched, east window with intersecting tracery. The west tower has an C18 window as south aisle. The tower has a late C19 brick upper part with small lancets and a hipped slate roof.

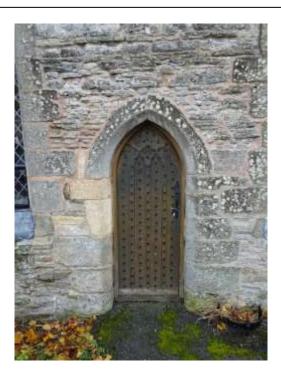
There is a level threshold with the tarmac path.

The timber door needs decoration.

Prepare and decorate the timber **C** door.
